Visualization of the elastic blade motion of an operating wind turbine

Göran Ronsten

Issuing organization FOI – Swedish Defence Research Agency Division of Aeronautics, FFA SE - 172 90 Stockholm	Report number, ISRN FOI-R--1398--SE	Report type Base data report
	Research area code Civil applications	
	Month year April 2005	Project no. E870363
	Customers code Civil applications	
	Sub area code Contracted Research	
Author/s (editor/s) Göran Ronsten	Project manager Göran Ronsten	
	Approved by Björn Montgomerie	
	Scientifically and technically responsible Göran Ronsten	
Report title (In translation) Visualization of the elastic blade motion of an operating wind turbine		
Abstract (not more than 200 words) <p>Blade elastic displacement were successfully tracked by means of digital photographic recording using both Light Emitting Diodes; LEDs, and reflexes mounted on a wind turbine blade. A procedure for image analysis was developed. The output from the image analysis was co-ordinates of the objects under investigation. Although the method developed is useful in producing results it still remains to verify the integrity of the results versus, for example, load measurements. The image ana

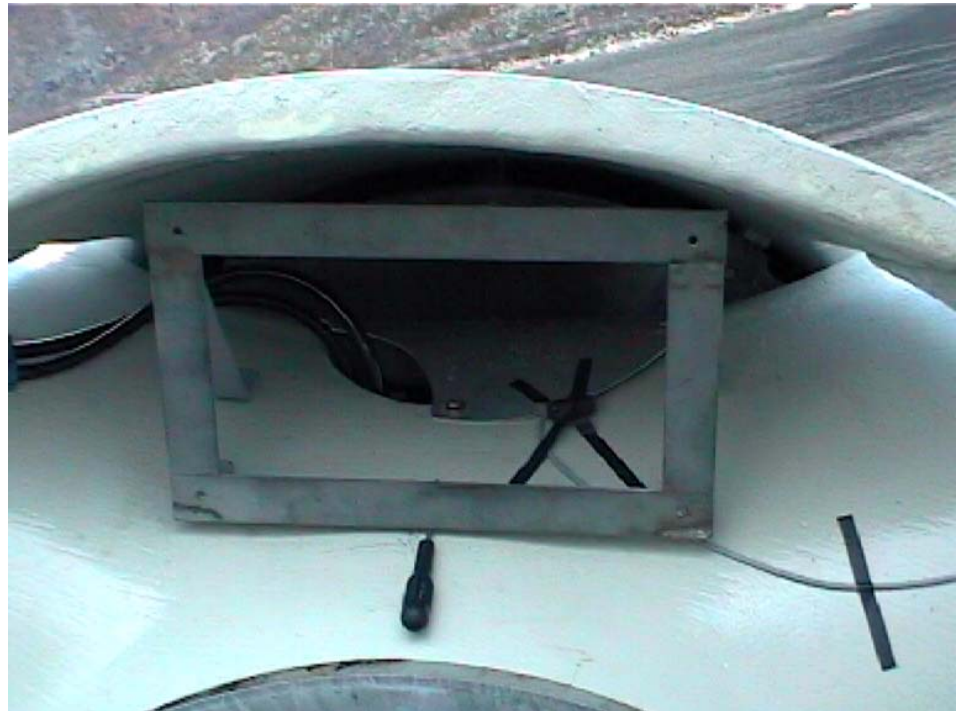
Figure 2. Mounting frame, hub computer.

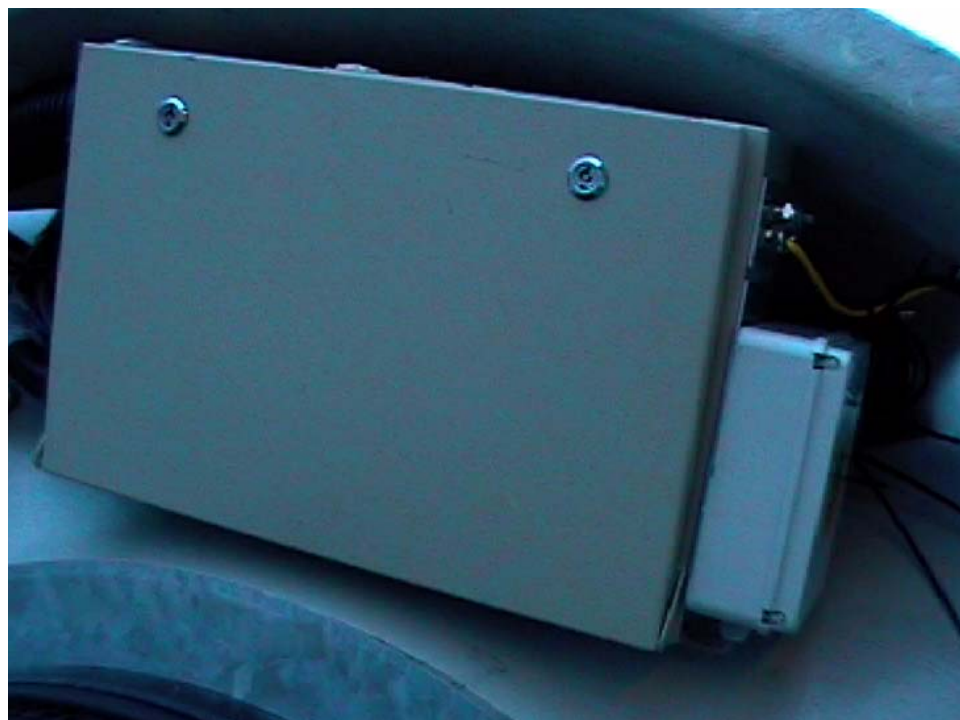
Figure 3. Hub computer. The box on the right contains electronics to control the camera lens.

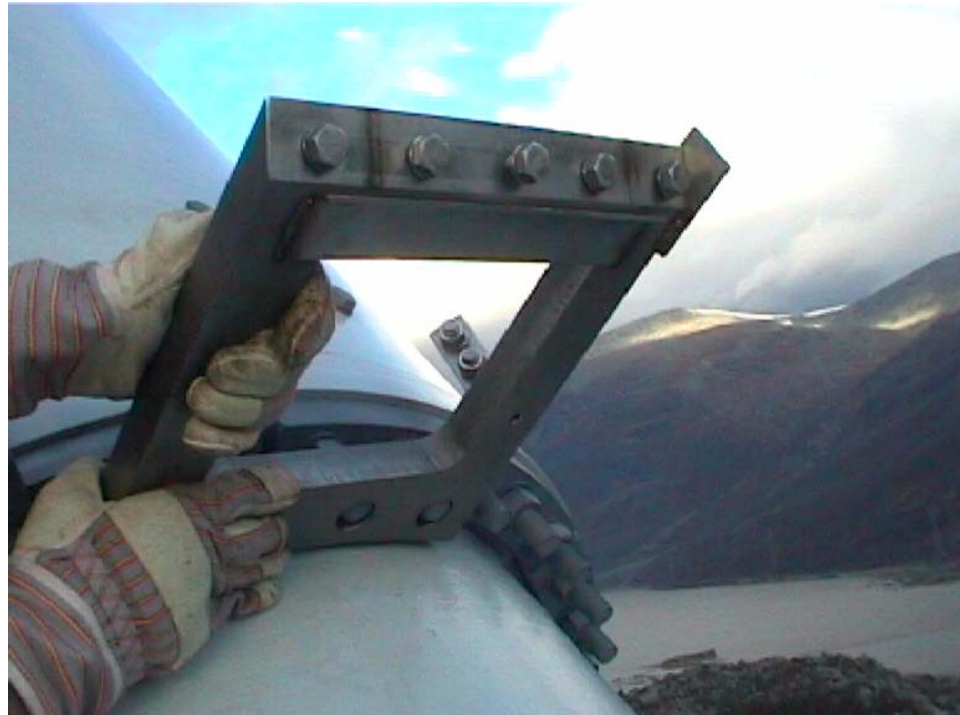
Figure 6. Attachment of camera house.

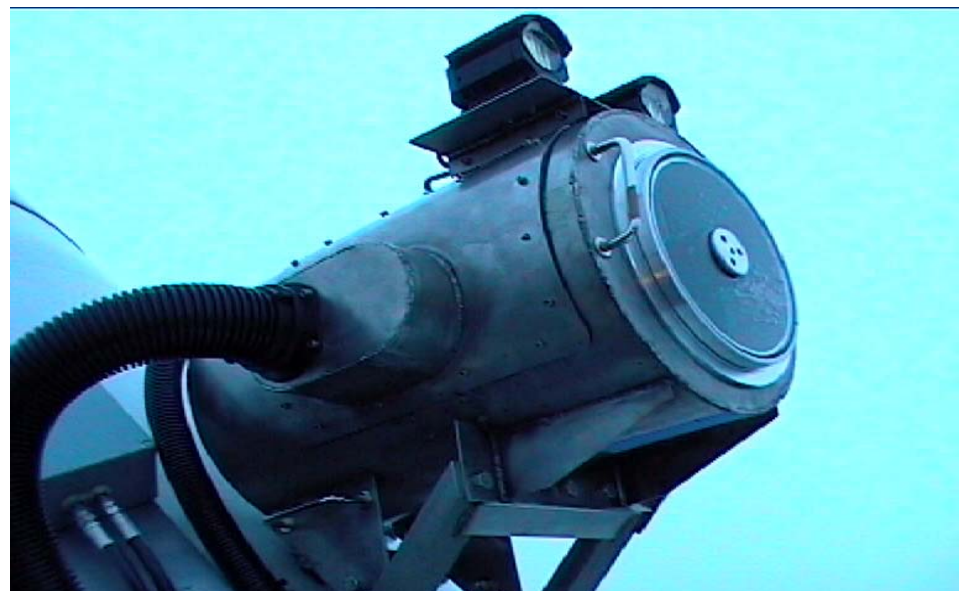
Figure 7. The camera house is equipped with a rotating clear view screen and a 400 W heating element.

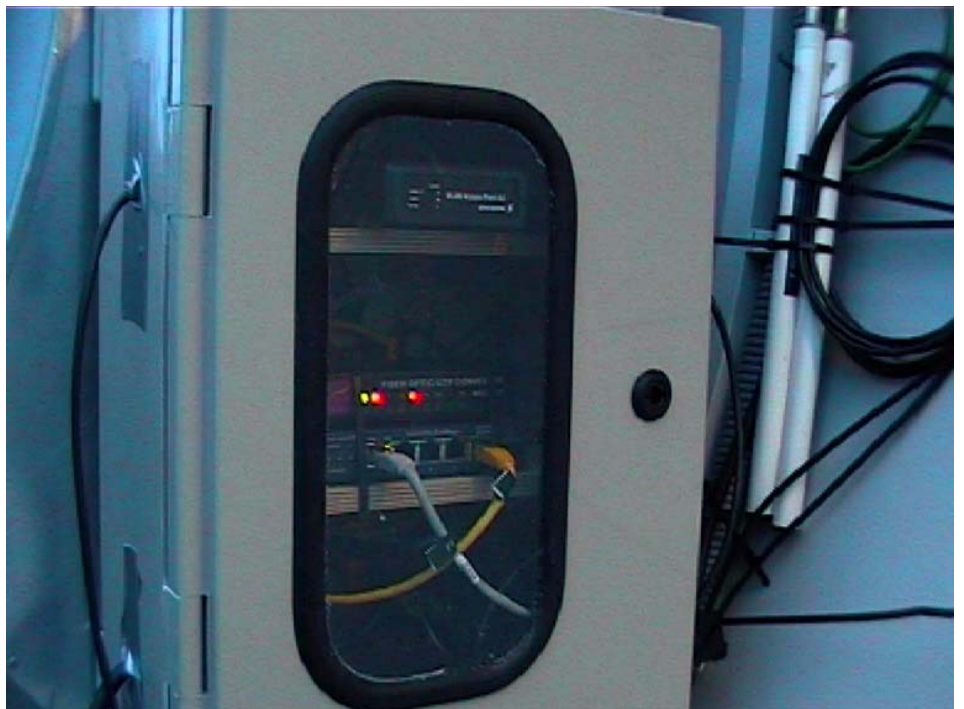
Figure 9. Nacelle mounted box containing wireless network connection. Two antennas on the hub and two antennas in the nacelle were used to secure proper functionality. The two antennas in the nacelle can be seen to the right of the box. The antennas were (of course) mounted apart during operation of the measurement system.

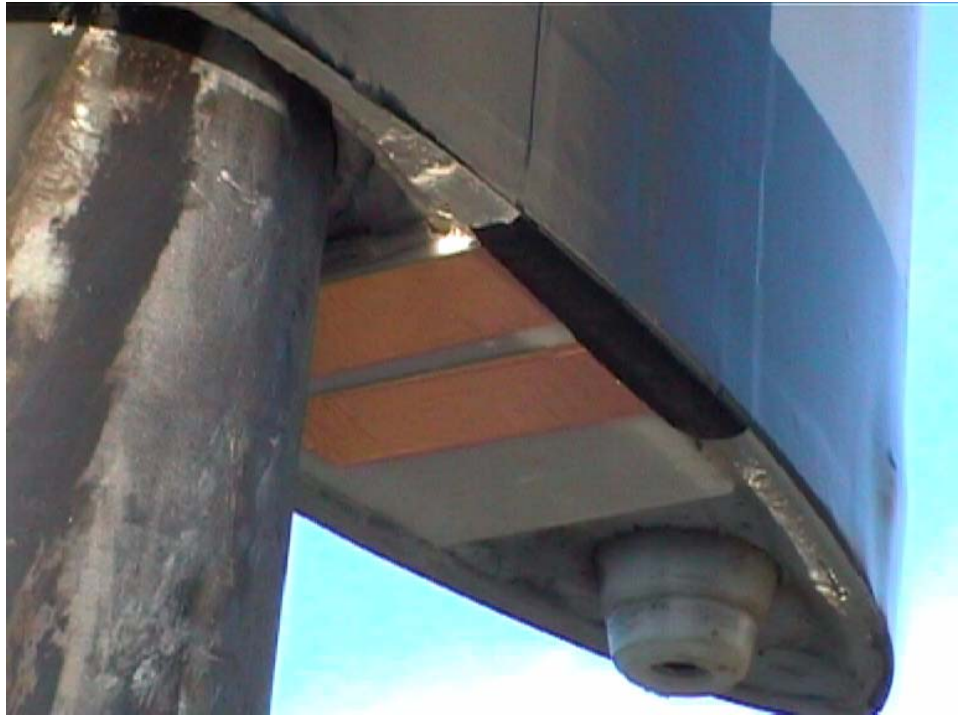
Figure 12. Electrical connection at the end of the fixed part of the blade appearing as two sheets of copper, The “stem” on the left is the tip pitching shaft.

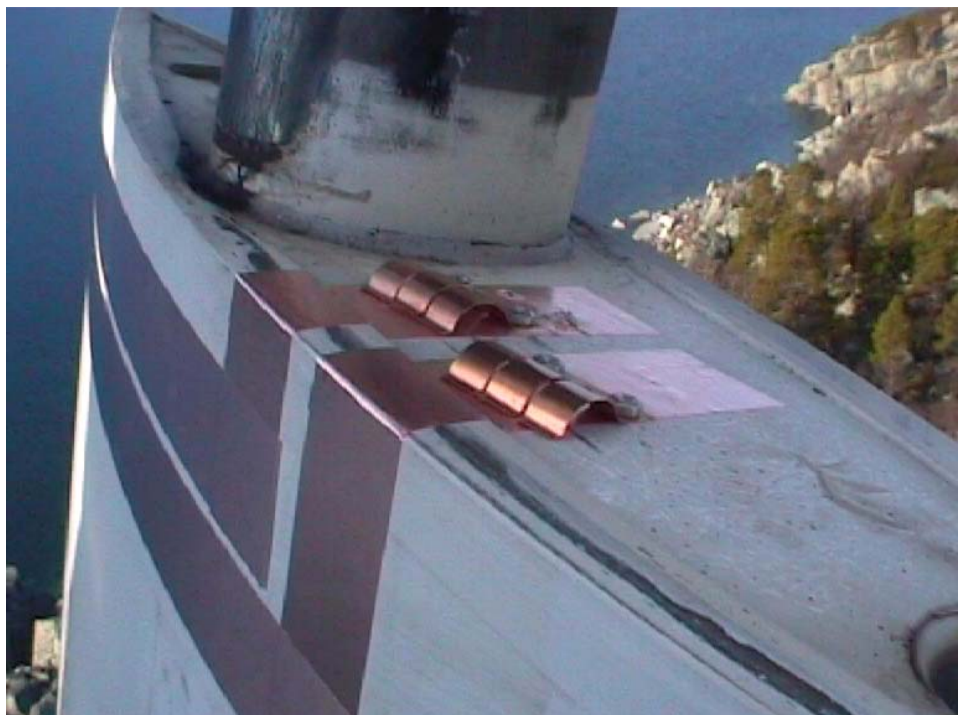
Figure 13. Electrical connection on the extendable and pitching blade tip.

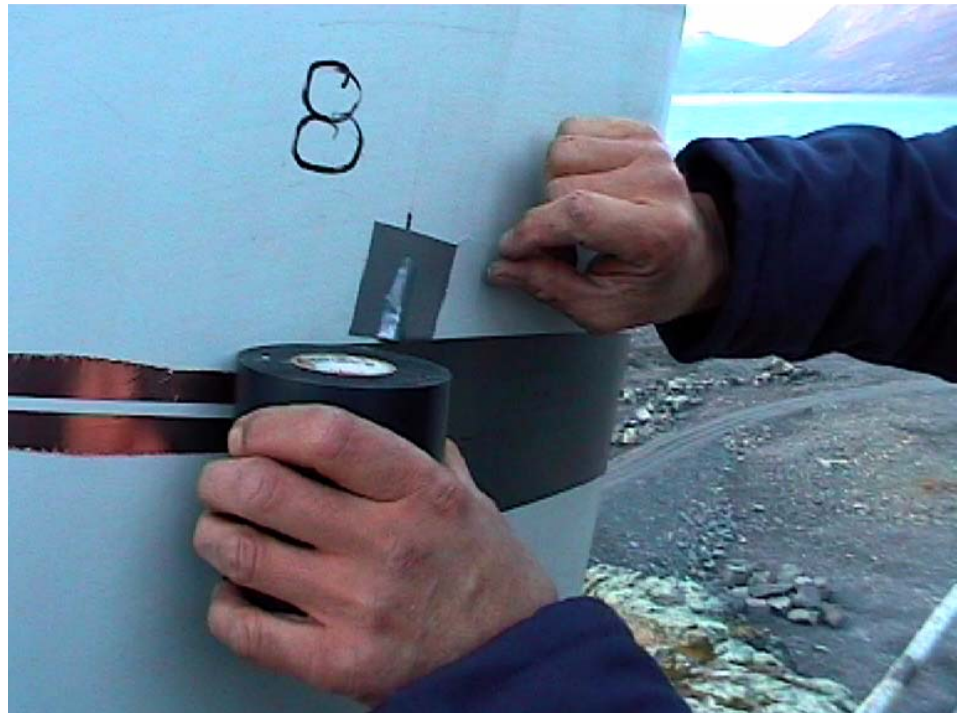
Figure 14. The copper tape is covered by insulating tape.

The tape covering the LED conductors at the blade tip had been worn down during operation. This finally resulted in a short circuit which turned off the LEDs.

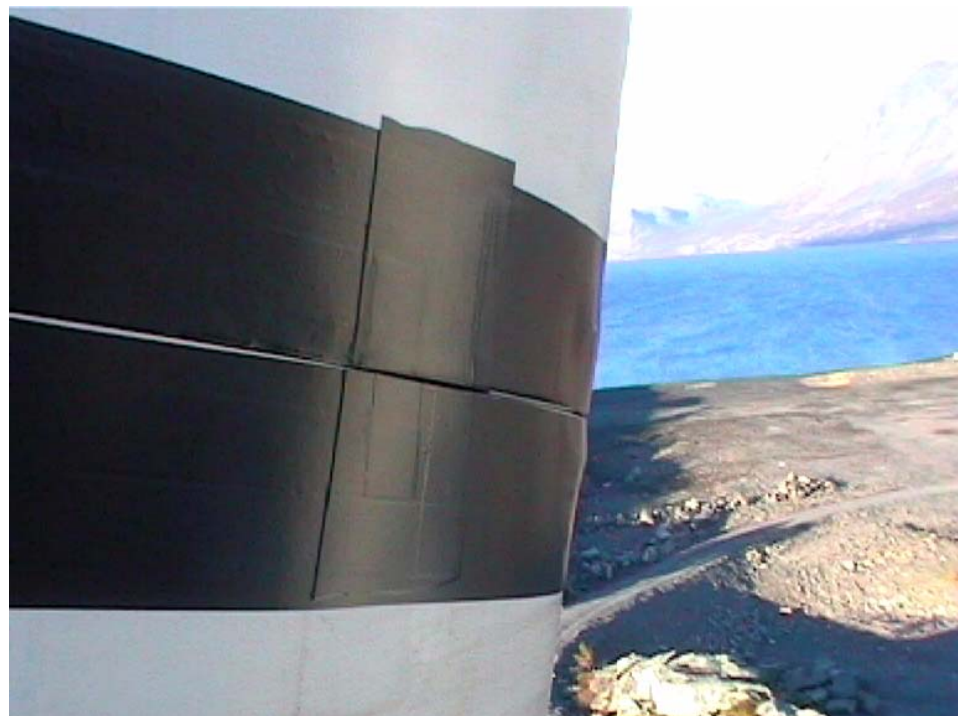
Figure 15. Blade-tip connection.

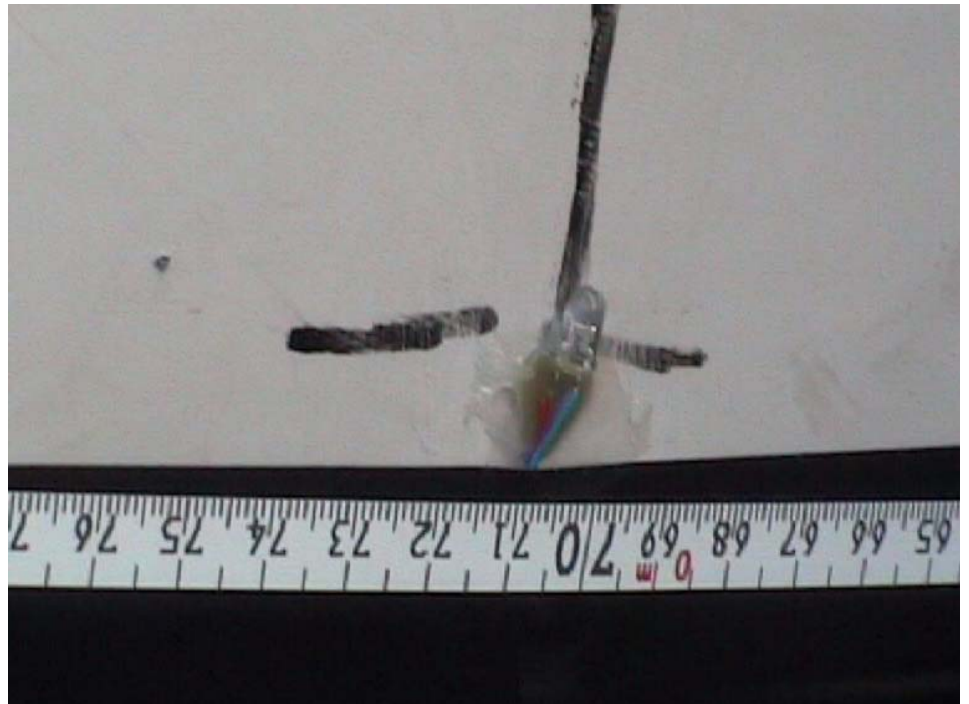
Figure 16. The LEDs were attached using epoxy adhesive.

Light emitting diodes (LEDs) were attached to the surface of the blade to provide fixed reference points for the camera system.

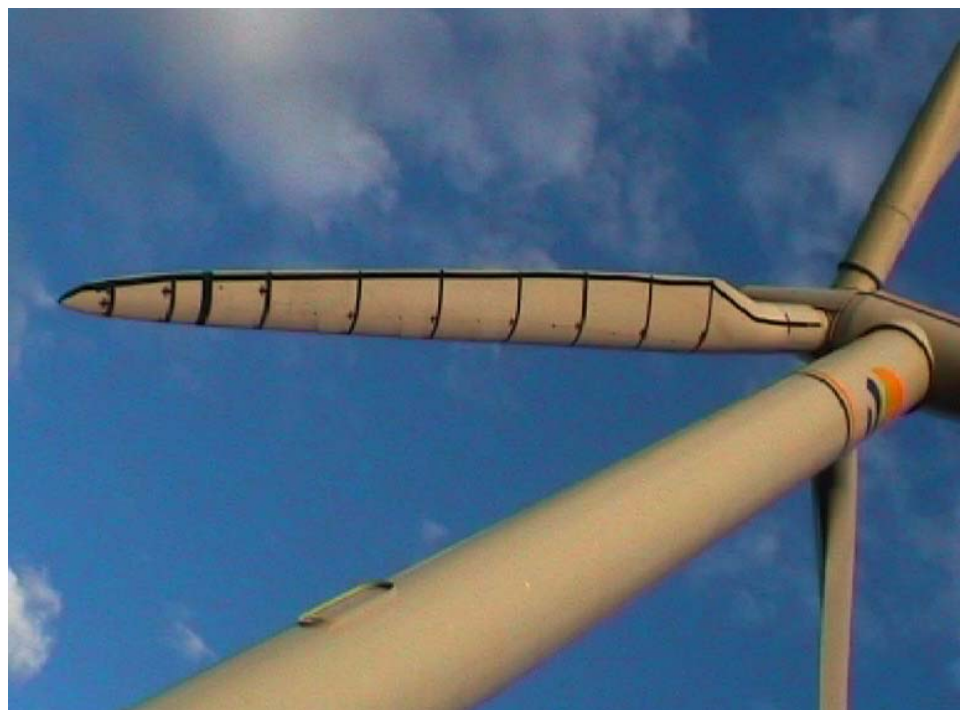
Figure 17. The instrumented blade.

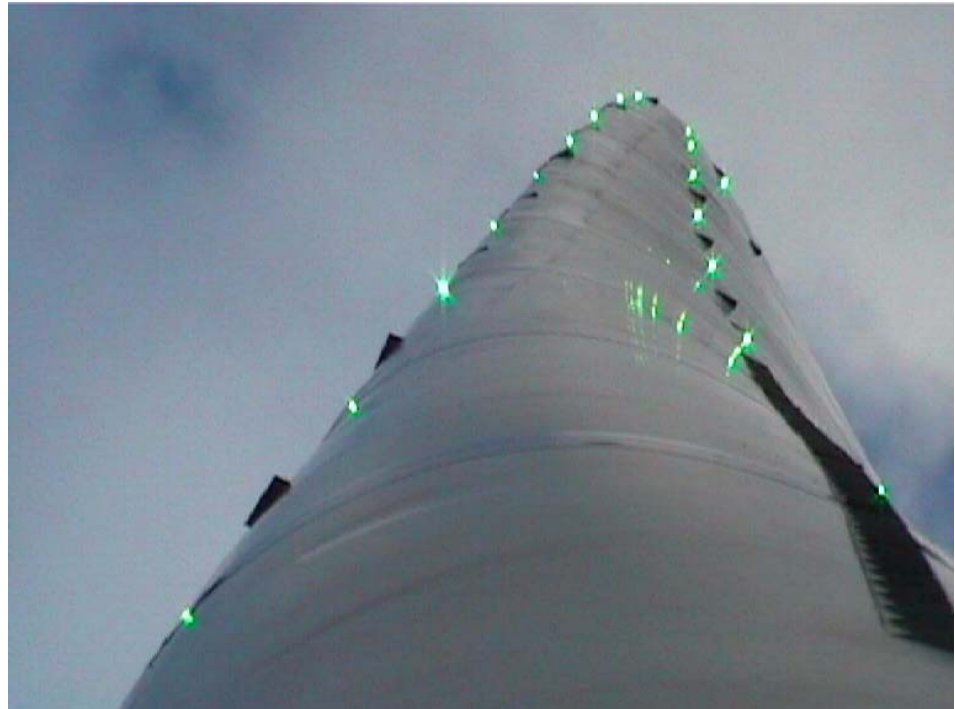
Figure 18. LEDs in operation.

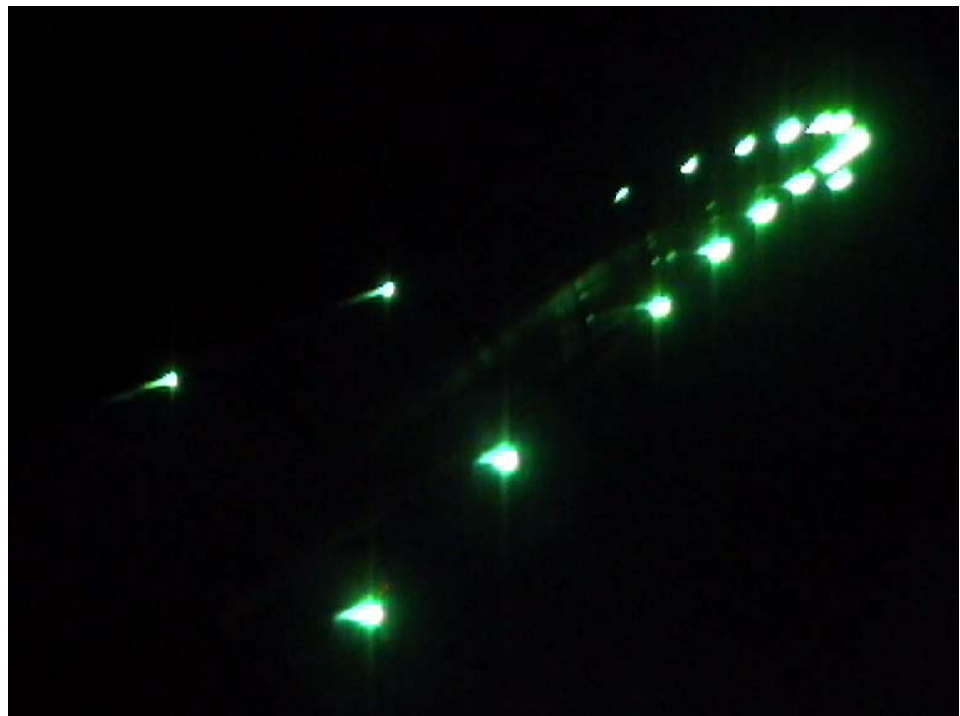
Figure 19. The instrumented blade at night captured by a video camera.

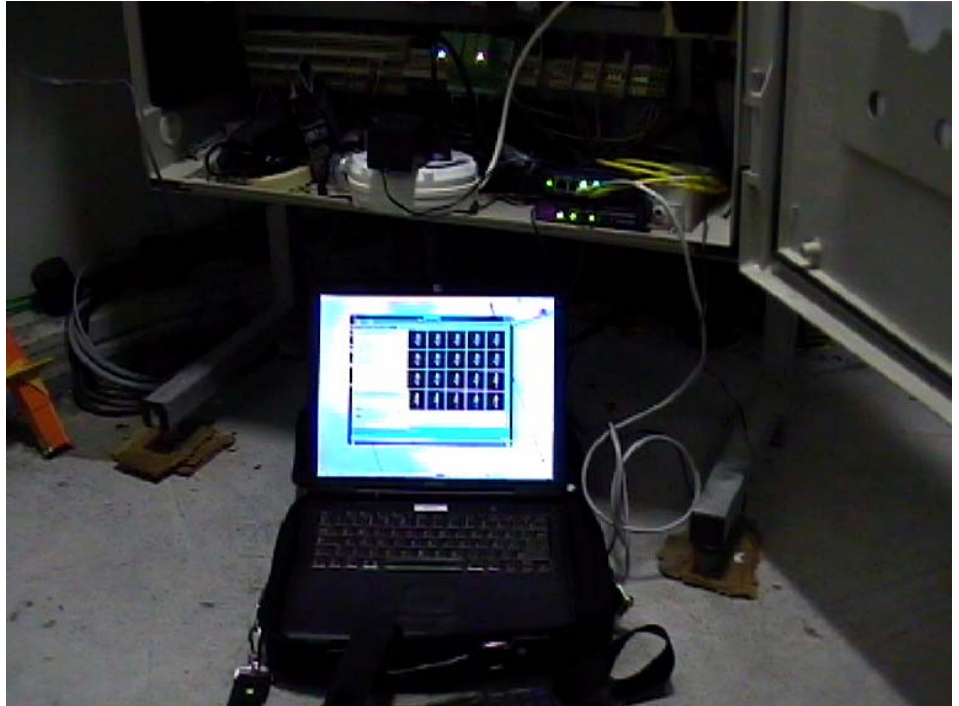
Figure 20. Network connection in tower base. A sequence of blade images are shown on screen.

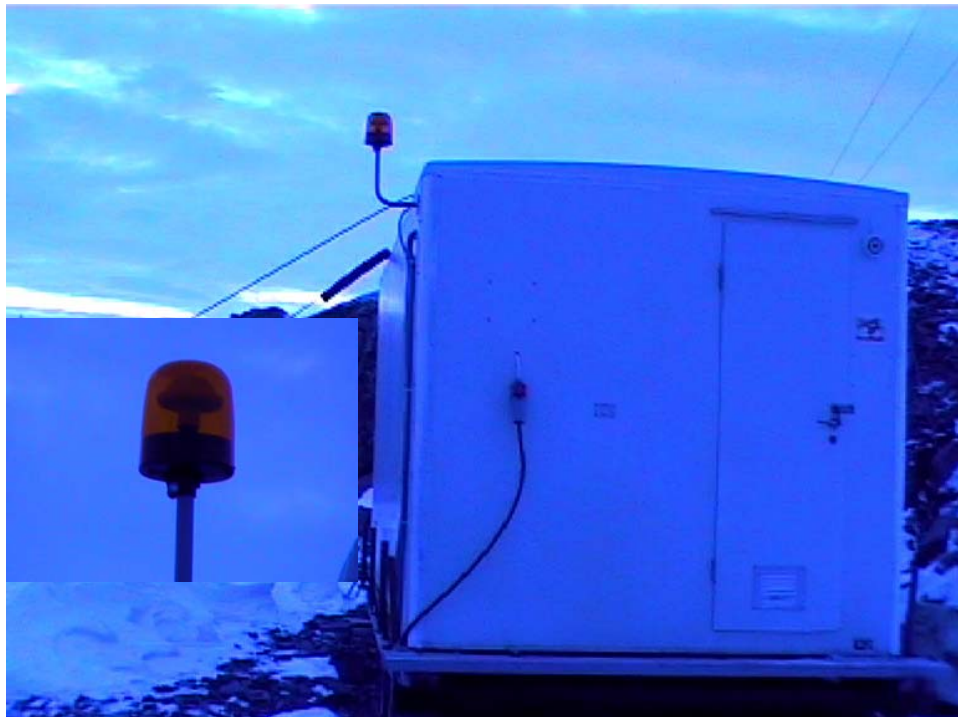
Figure 21. Cabin with an external GPS-antenna for time synchronization with meteorological data.

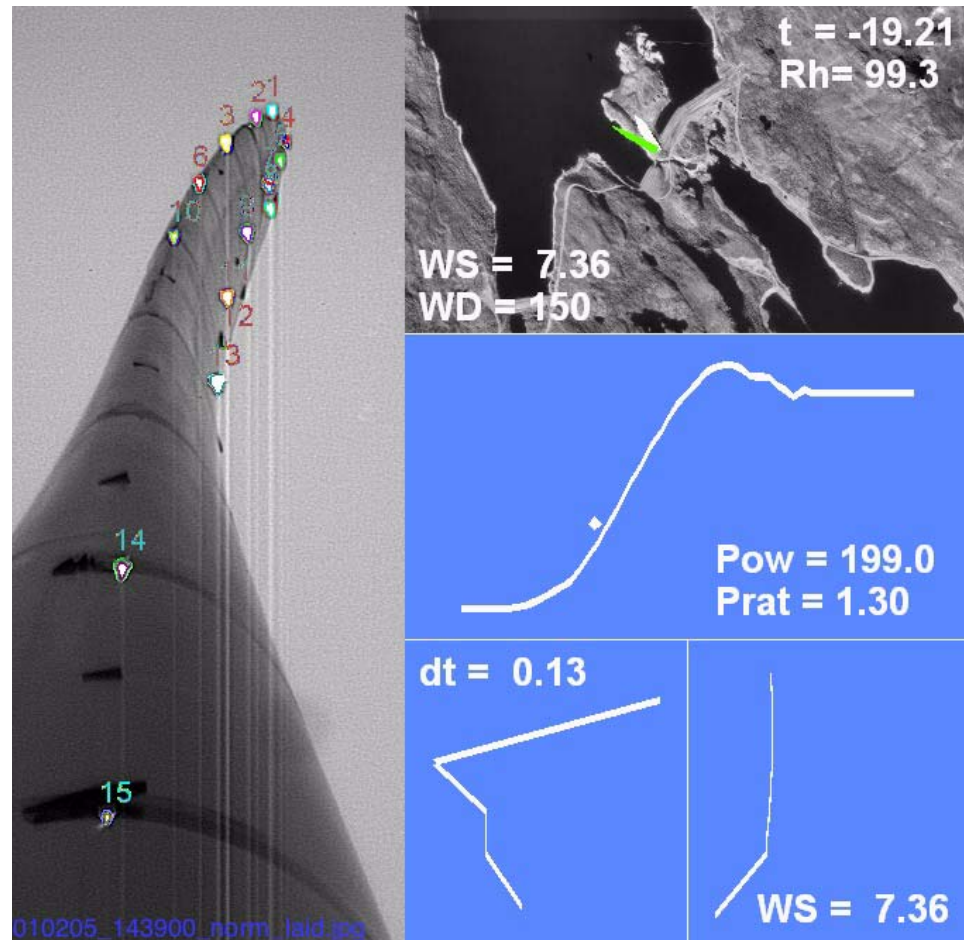
Figure 24. Image of LEDs mounted on the blade. All meteorological data is 10 minute averages except the green wind speed indicator which is sampled at 1 Hz.

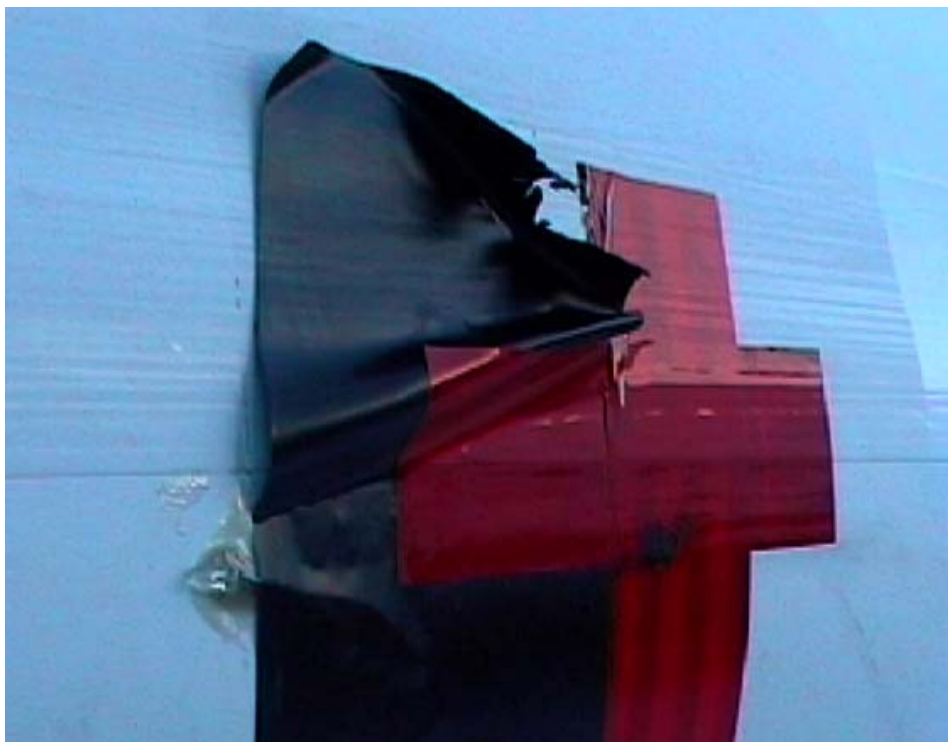
Figure 25. The insulating tape came off partly close to the leading edge. The air speed at the tip is in the order of 300 km/h.

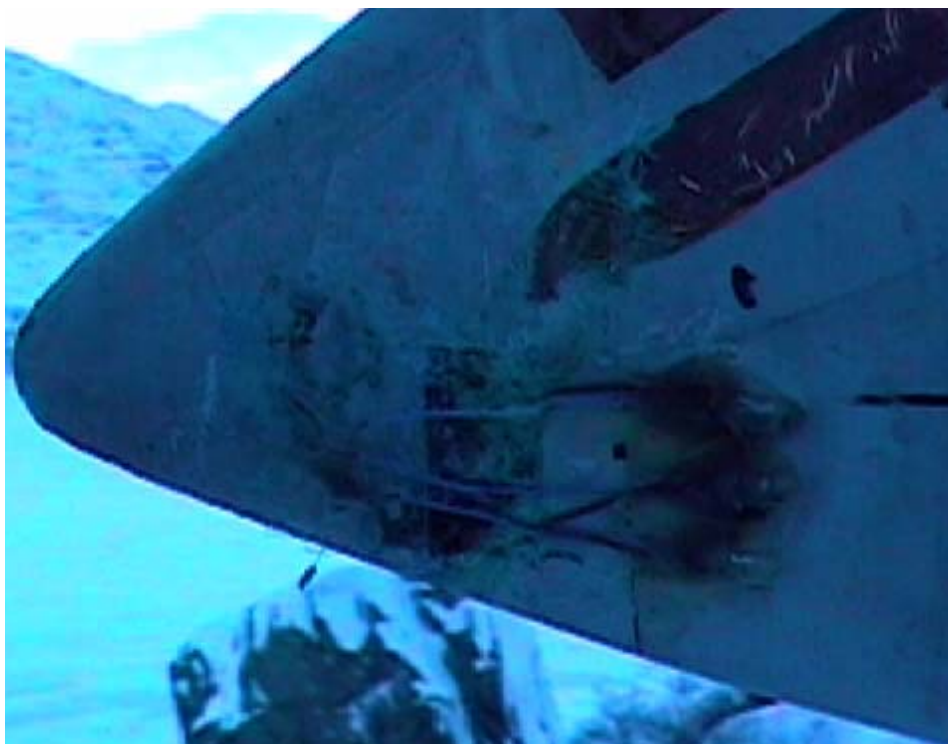
Figure 26. Corrosion broke the electrical connection at the blade tip.

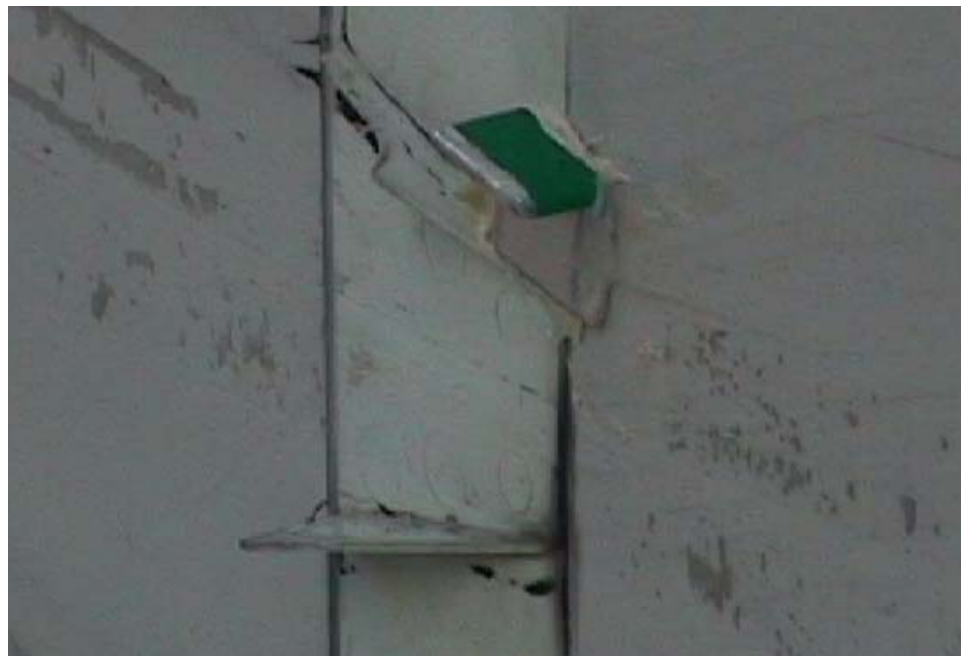
Figure 27. Green reflector tag close to a vortex generator 16 m from the blade tip.

Figure 32. Reflector tags at 0.1, 2.1, 4, 6, 8, 10, 12, 14 & 16 m from the tip. The innermost tag is also shown in Figure 27 on page 22.

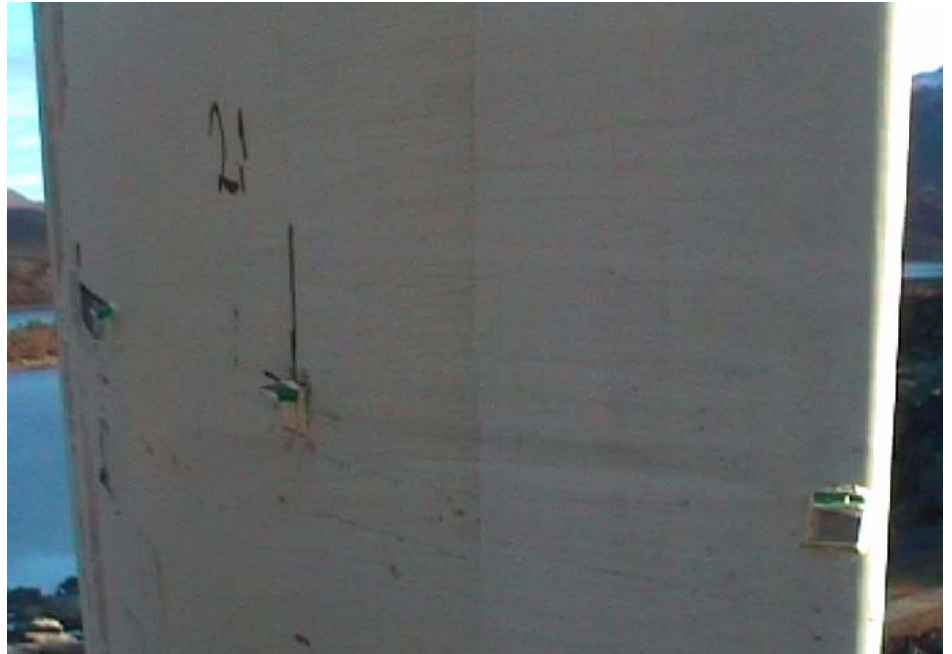
Figure 28. Reflector tags at 2.1 m from the blade tip.

Figure 30. Reflector tags at 0.1, 2.1, 4.6, 8 & 10 m from the tip. The outermost tags are also shown in Figure 28 and Figure 29.

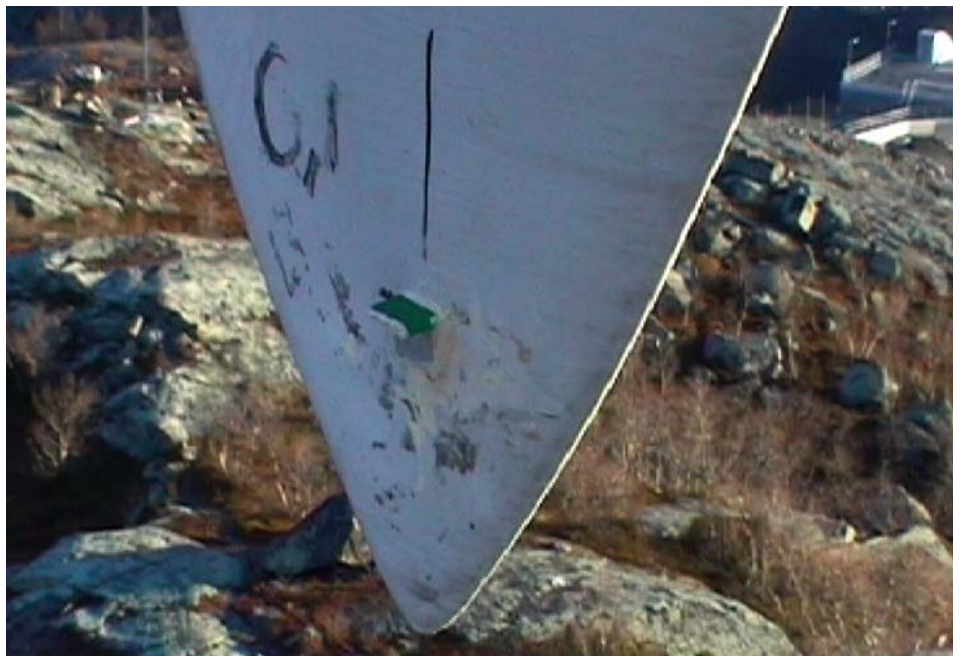
Figure 29. reflector tag attached 0.1 m from the blade tip.

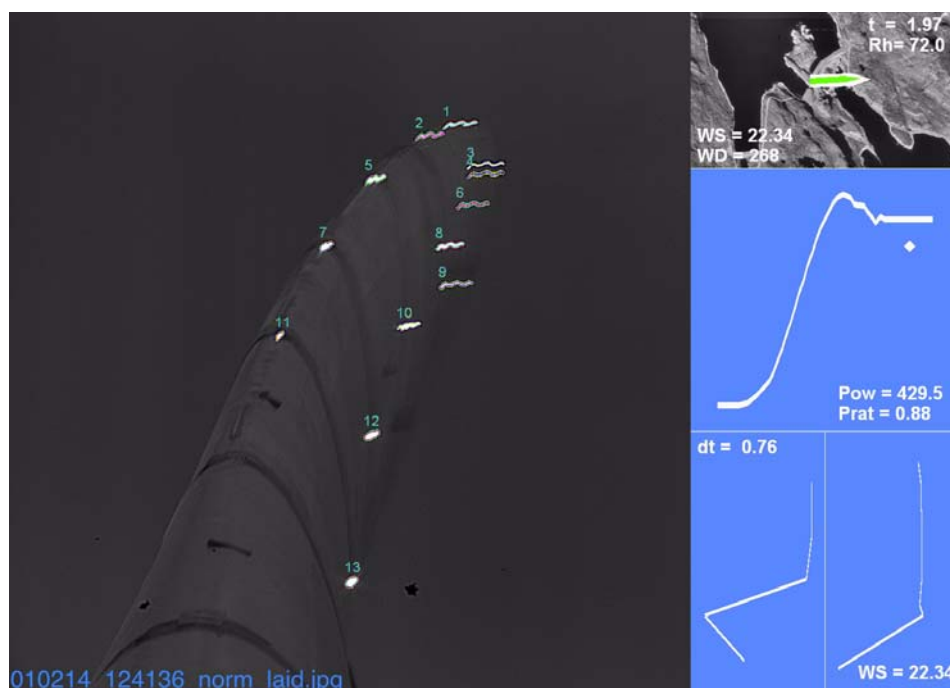
Figure 34. A 78 ms exposure time was used to capture blade movements.

A large flapwise deflection with an edgewise overlay is shown in Figure 34. The following image, Figure 35, shows the blade at the turning point in the flapwise direction.

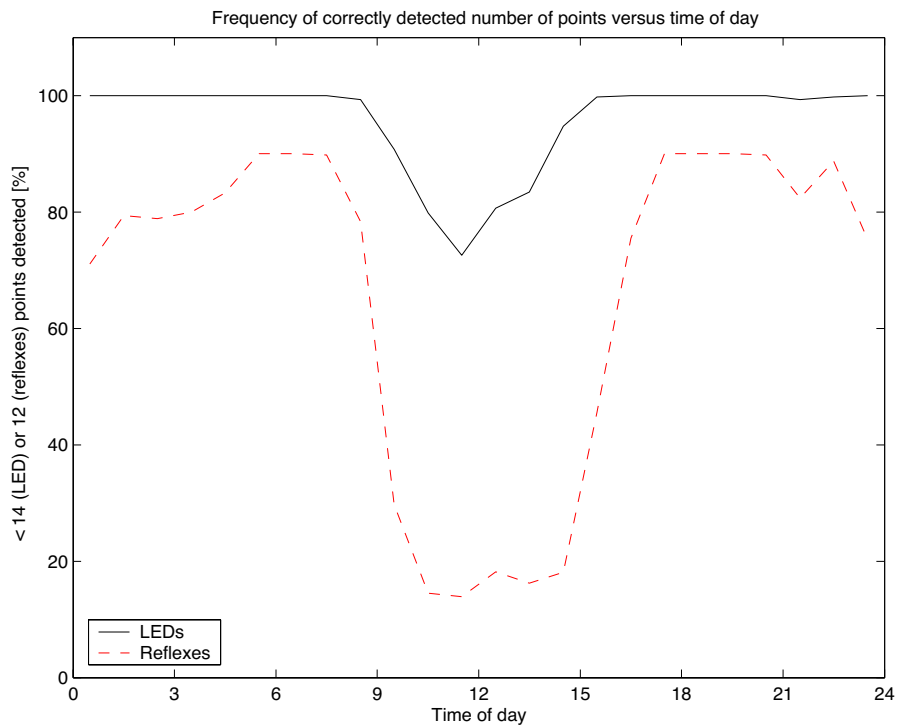
Figure 37. Frequency of correctly determined number of point versus time of day.

Figure 36 shows that daylight conditions made it more difficult to locate the targets. This result could have been improved by restricting the images to certain azimuthal angles thereby optimizing the aperture for a smaller variation of the incoming light. Storing nearby data points in bins and calculating statistical data is shown in Figure 37.

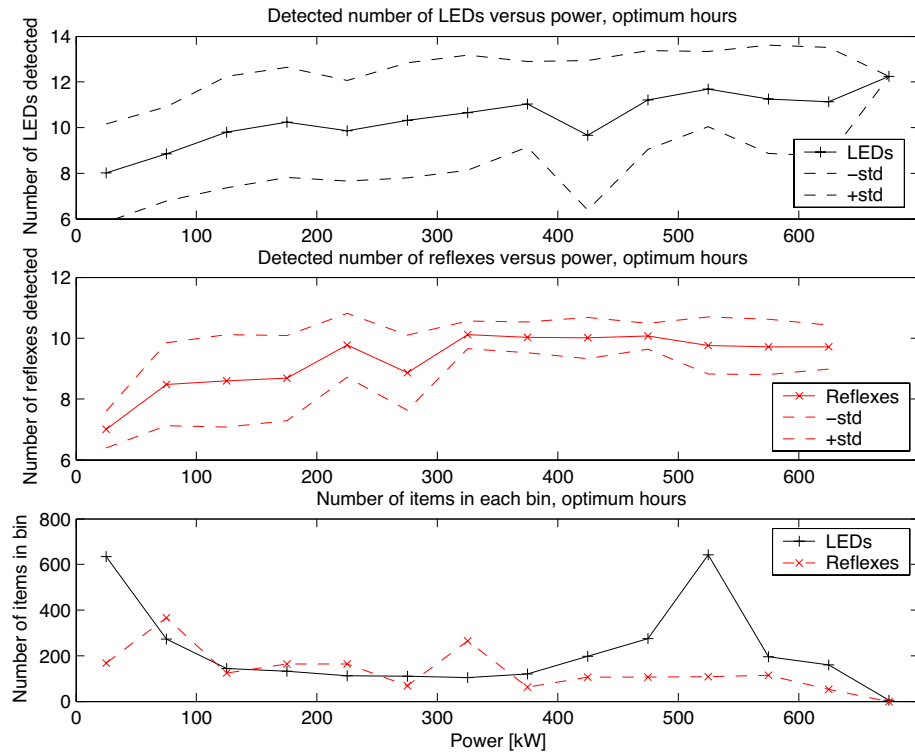
Figure 38. Number of points detected versus power.

The number of points detected should increase as the blade deflects, Figure 38.

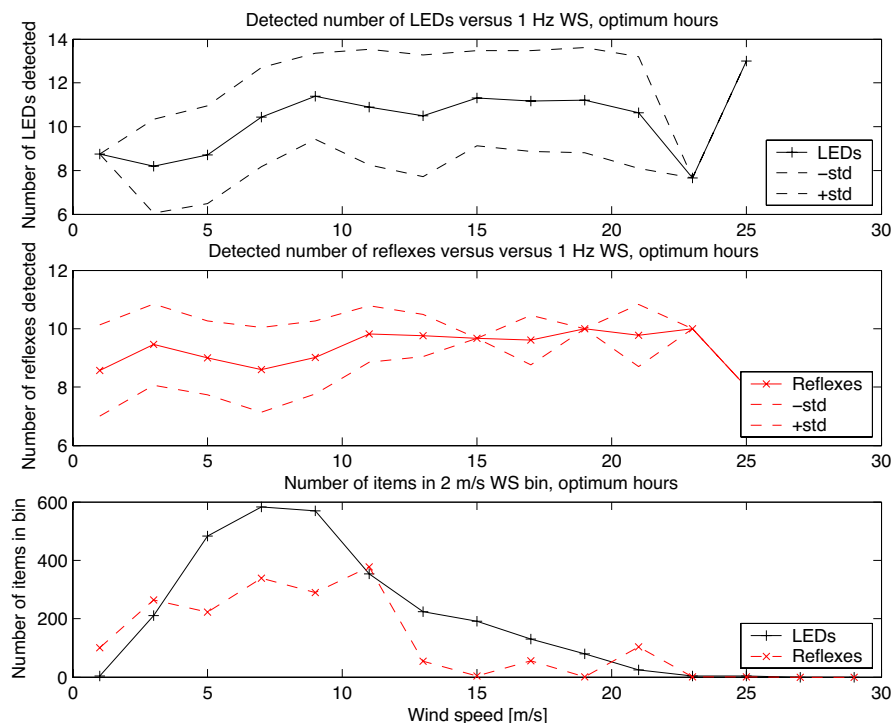
Figure 39. Number of points detected versus wind speed.

The power produced below and above rated wind speed can be of equal magnitude at more than one wind speed. Figure 39 shows the number of points detected versus wind speed.

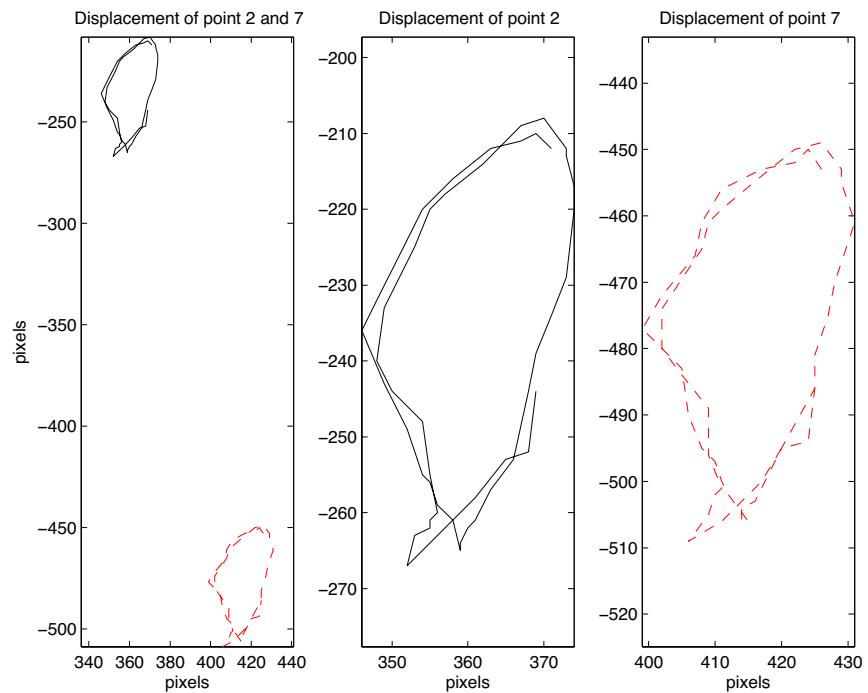
Figure 41. Displacement of point 2 and 7 in 50 sequential images, 4 sec sequence 2003-01-27 at 00.00.

Blade elastic displacement were successfully tracked by means of digital photographic recording using both Light Emitting Diodes; LEDs, and reflexes mounted on a wind turbine blade, **Figure 41** and **Figure 42**. A procedure for image analysis was developed using LabView, a software from National Instruments. The output from the image analysis was co-ordinates of the objects under investigation. Although the method developed is useful in producing results it still remains to verify the integrity of the results versus, for example, load measurements.

The co-ordinates of point #2 and #7 are shown in

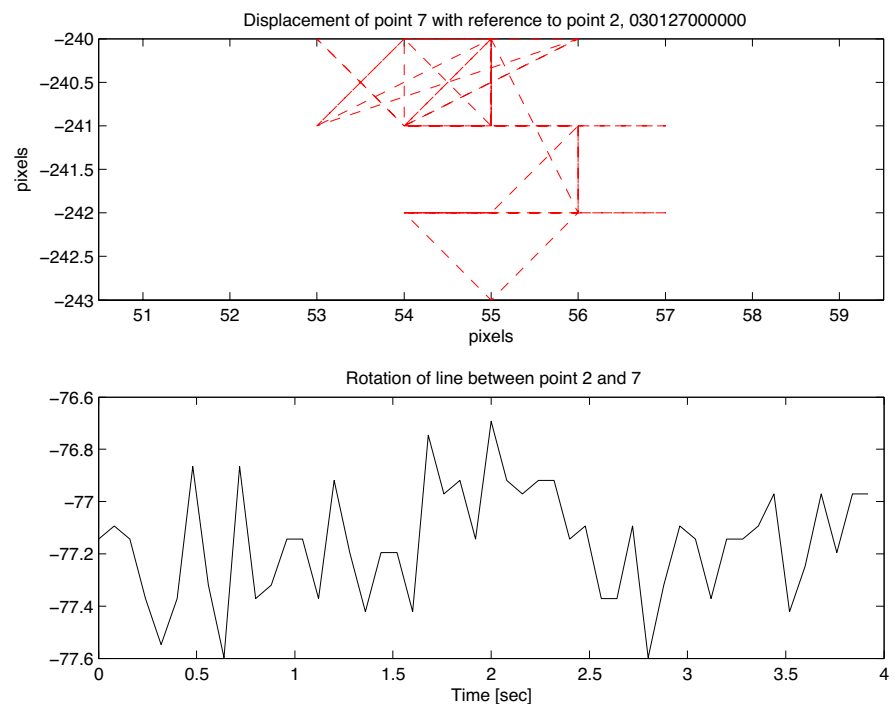
Figure 42. Displacement and angular variation of point 7 with reference to point 2 in 50 images, 4 sec sequence 2003-01-27 at 00.00.

The distance between the reflexes is known. This enables transformation to units of interest, such as mm, to be carried out.

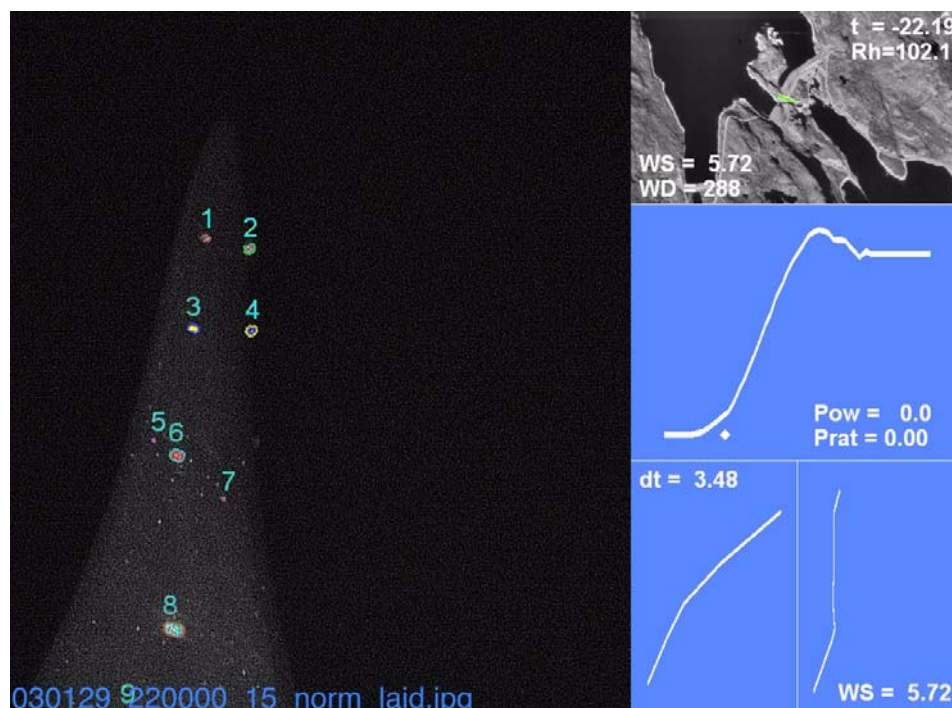
Figure 45. The iced up blade at stand still during night. The reflexes can be seen through the ice cover whereas they're less easy to detect during daylight. Icing occurred at a temperature around -20° .

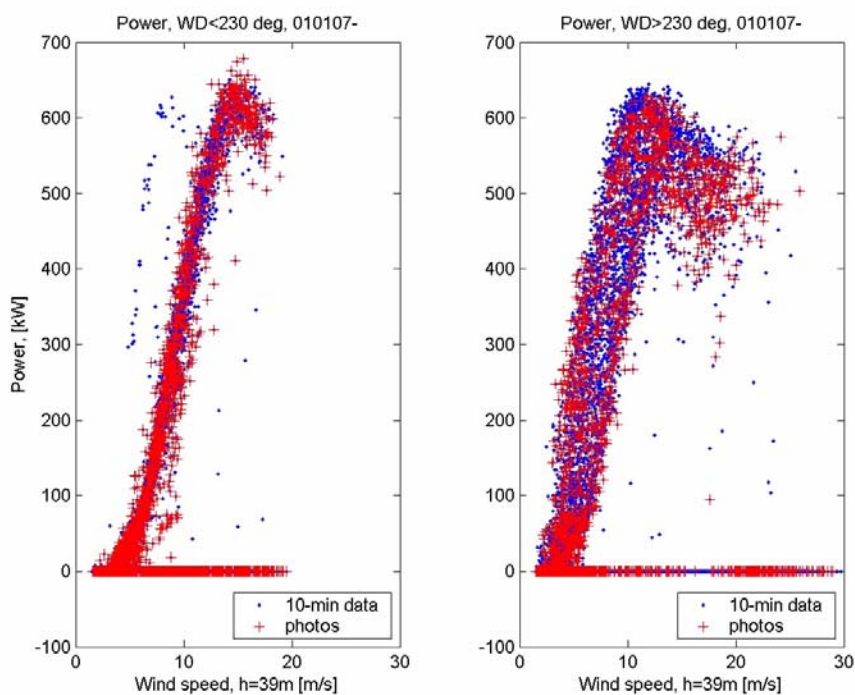
Figure 46. 10 minute averages of wind speed versus power. All situations are plotted in blue while conditions from which a photo is available are shown in red.

The difference between the two plots shown above is the wind direction. The measurement mast is sheltered in the second graph.

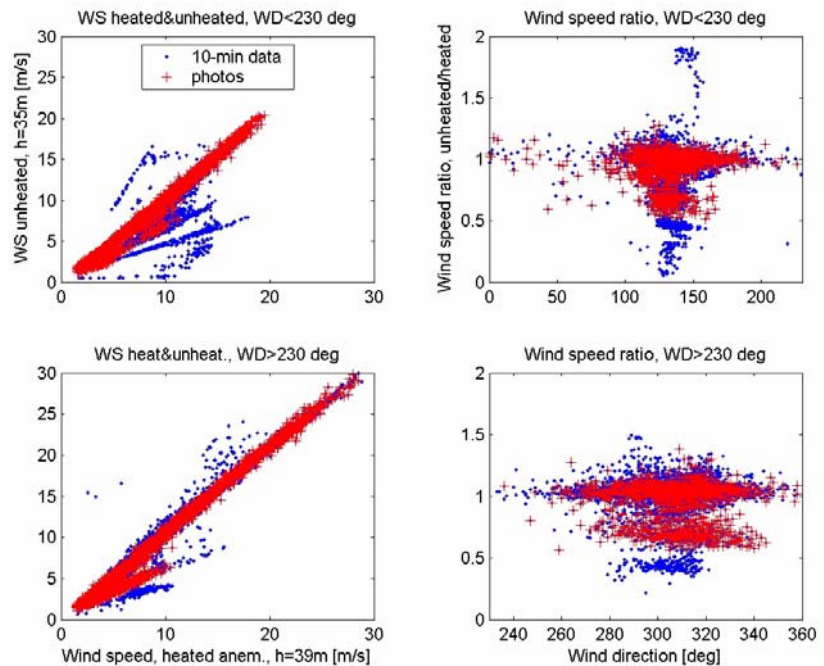
Figure 47. 10 minute averages of wind speed measured using a heated anemometer at h=39 m compared to non-heated at h=35 m. All situations are plotted in blue while conditions from which a photo is available is shown in red.

The lower wind speed measured at h=35 m in front of and behind the mast can also be caused by the tower shadow. Such sectors should be deleted in comparisons aiming at detecting ice.

Wind speed measured using a heated anemometer can be compared to ditto measured by a non-heated anemometer to determine icing, Figure 47.

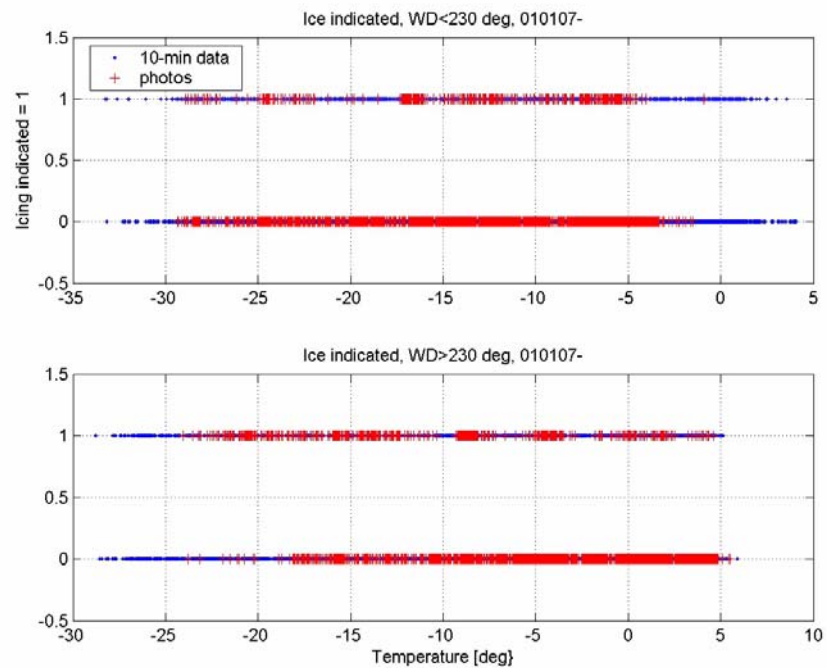
Figure 48. Icing occurs, according to the ice detector signal mounted on the nacelle at temperatures down to -35° .

There is an ice detector mounted on the nacelle, Figure 48. Data were divided into two opposite wind directions. One conclusion is that icing is indicated as low as close to -35° .
