Visualization of the elastic blade motion of an operating wind turbine

Göran Ronsten

Issuing organization FOI – Swedish Defence Research Agency Division of Aeronautics, FFA SE - 172 90 Stockholm	Report number, ISRN FOI-R--1398--SE	Report type Base data report
	Research area code Civil applications	
	Month year April 2005	Project no. E870363
	Customers code Civil applications	
	Sub area code Contracted Research	
Author/s (editor/s) Göran Ronsten	Project manager Göran Ronsten	
	Approved by Björn Montgomerie	
	Scientifically and technically responsible Göran Ronsten	
Report title (In translation) Visualization of the elastic blade motion of an operating wind turbine		
Abstract (not more than 200 words) <p>Blade elastic displacement were successfully tracked by means of digital photographic recording using both Light Emitting Diodes; LEDs, and reflexes mounted on a wind turbine blade. A procedure for image analysis was developed. The output from the image analysis was co-ordinates of the objects under investigation. Although the method developed is useful in producing results it still remains to verify the integrity of the results versus, for example, load measurements. The image ana

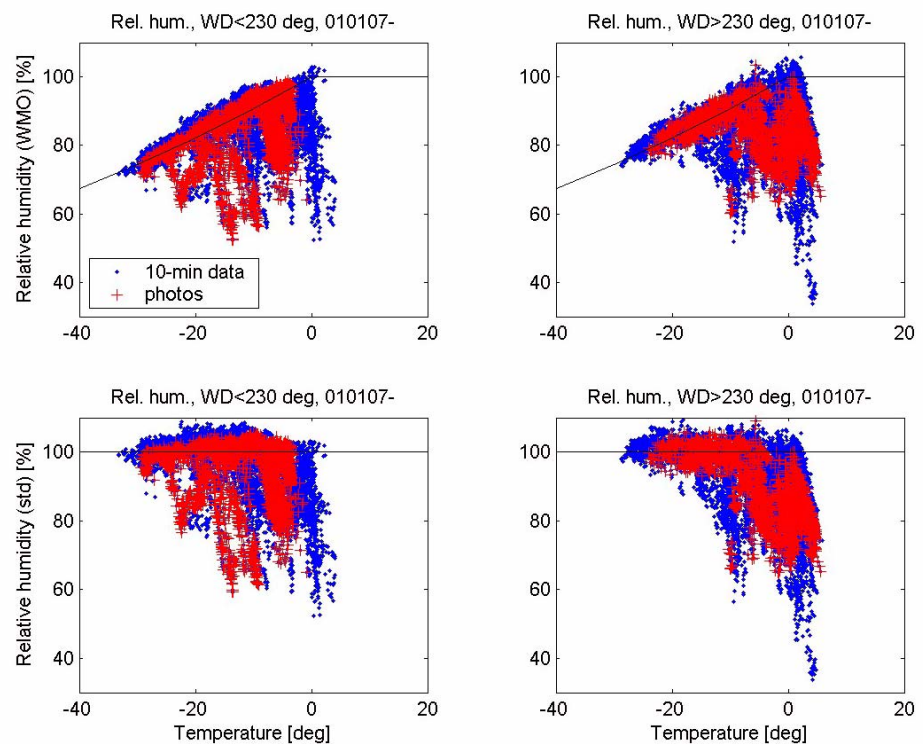
Figure 49. Relative humidity is traditionally measured not taking ice into account. Recalculating data below 0° with respect to ice might make it easier to determine when icing can be detected using ordinary meteorological instruments,

The relative humidity has since long been used to estimate the risk for icing. Recent findings by Makkonen et al. indicate that liquid water content and droplet size is of major importance for the formation of ice. However, these later parameters are, at present, not commonly measured at meteorological stations.
